# **2010 UPSTREAM PARCELS MONITORING REPORT**

**BAILEY'S BRANCH AND PLEASANT RUN REMOVAL ACTION  
BEDFORD, INDIANA**

**Prepared For:  
General Motors LLC**

**FEBRUARY 2011**

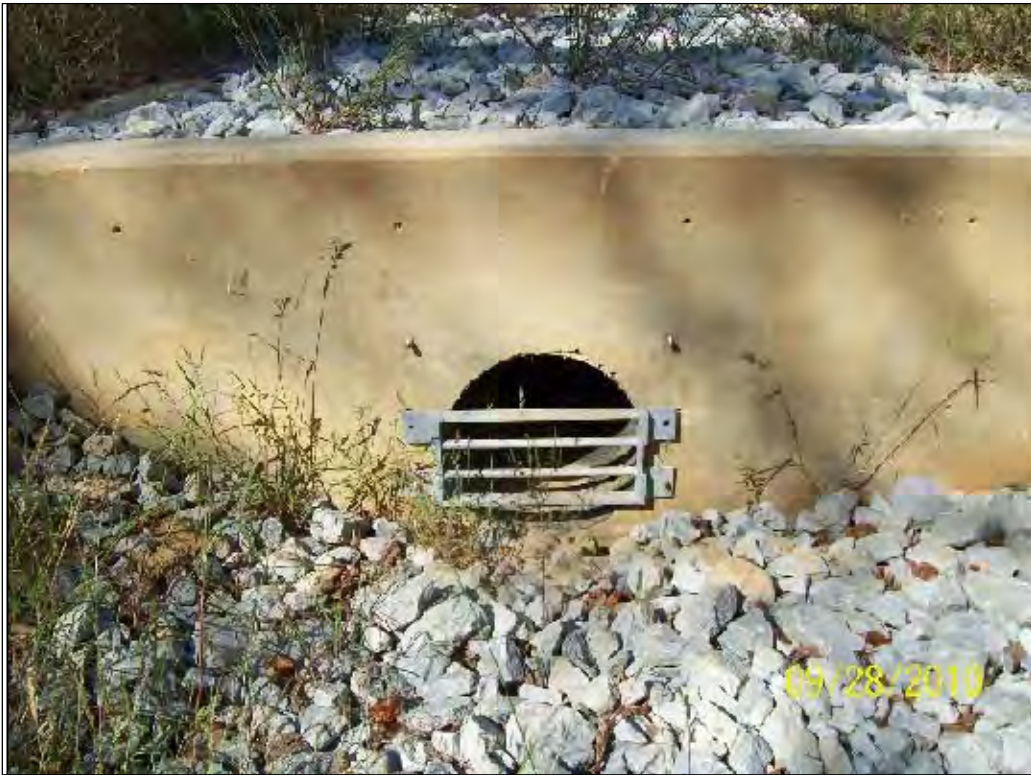
FIGURE 3.4 - PARCEL 3, LOCATION 3, SOUTH POND OUTLET

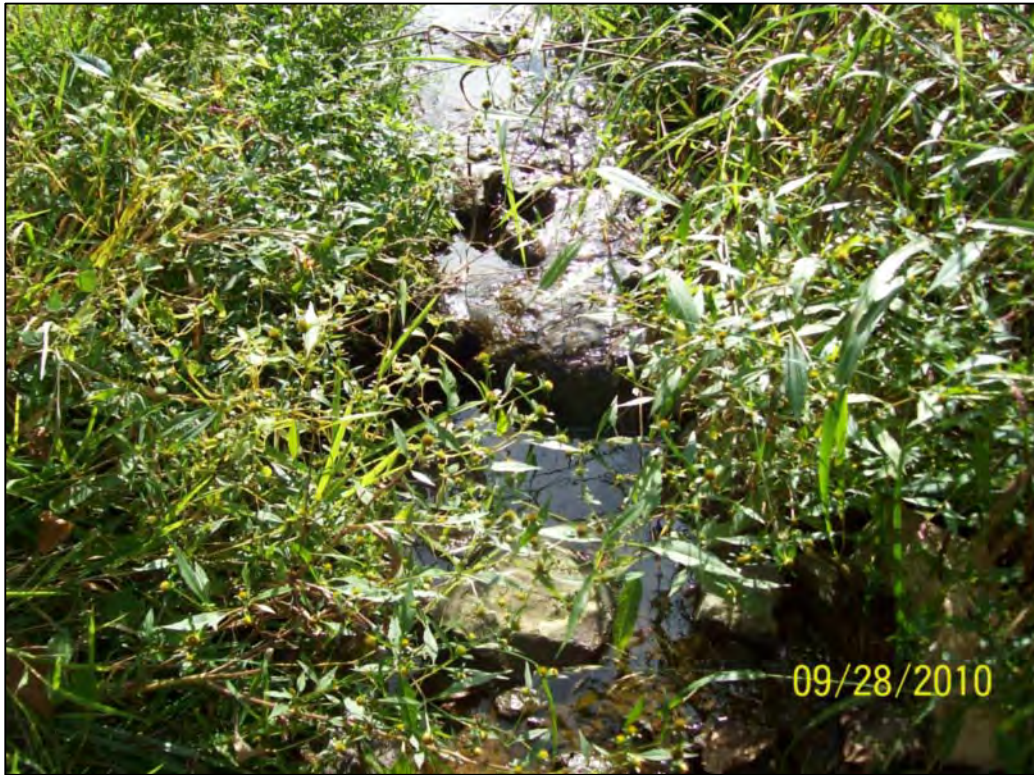
A number of rock current deflectors were installed to promote the formation of pool-riffle sequences within the channel. The rock current deflectors have performed as expected, remain largely intact, and are documented within the photo log in Appendix A (see Appendix A Figure 6, 7 and 9).

FIGURE 6.0 - PARCEL 6, LOCATION 6, LOOKING UPSTREAM, ROCK CURRENT DEFLECTOR

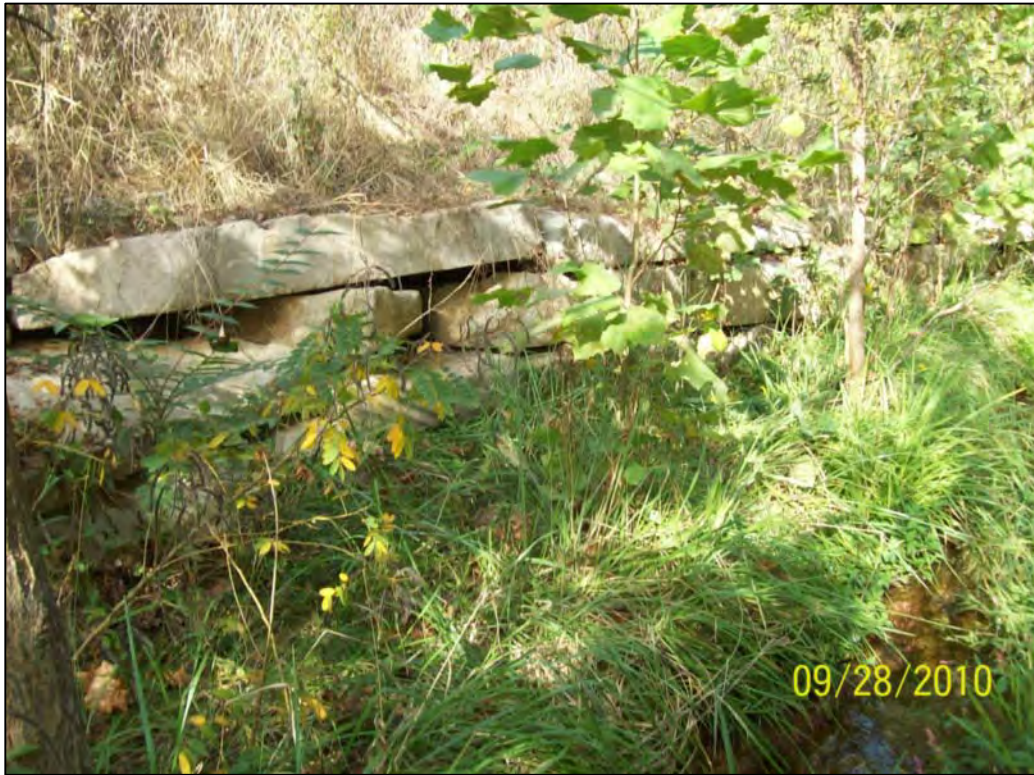
The banks along the length of the creek channel do not show visible signs of erosion, undercutting or failure. The bank stabilization features (i.e., log deflectors, limestone roughback deflectors) remain intact, showing no visible signs of failure.

FIGURE 6.2 - PARCEL 6, LOCATION 6, LOOKING DOWNSTREAM ROUGHBACK WALL (STABLE - NO MOVEMENT)

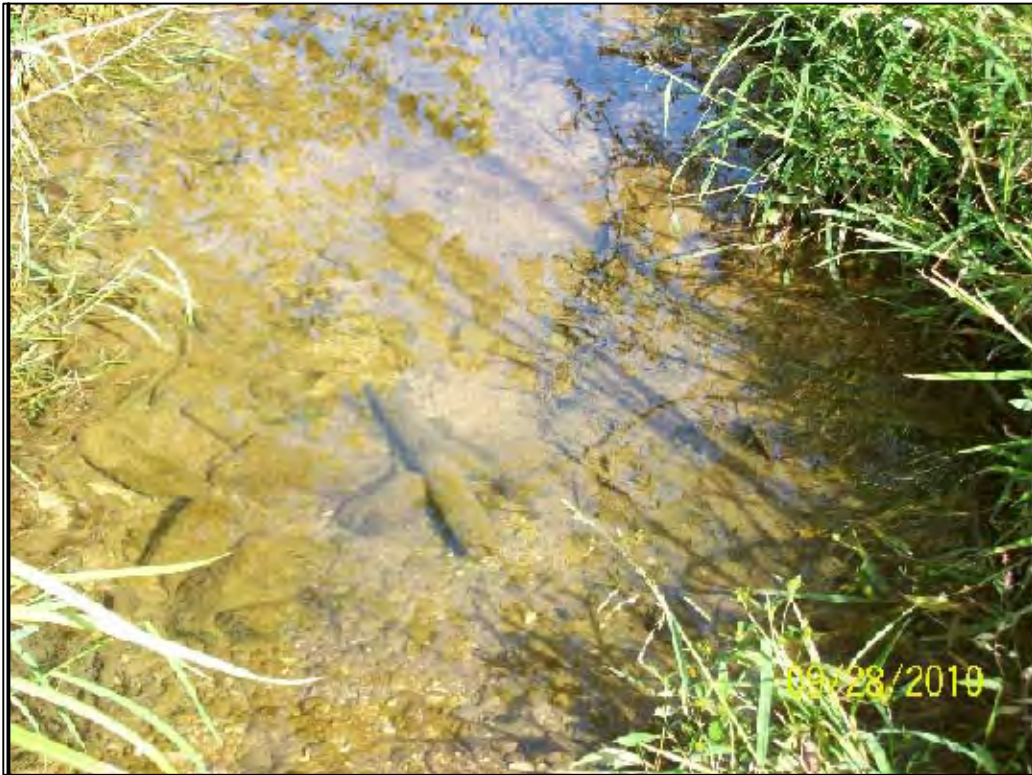
FIGURE 6.4 - PARCEL 6, LOCATION 6, POOL

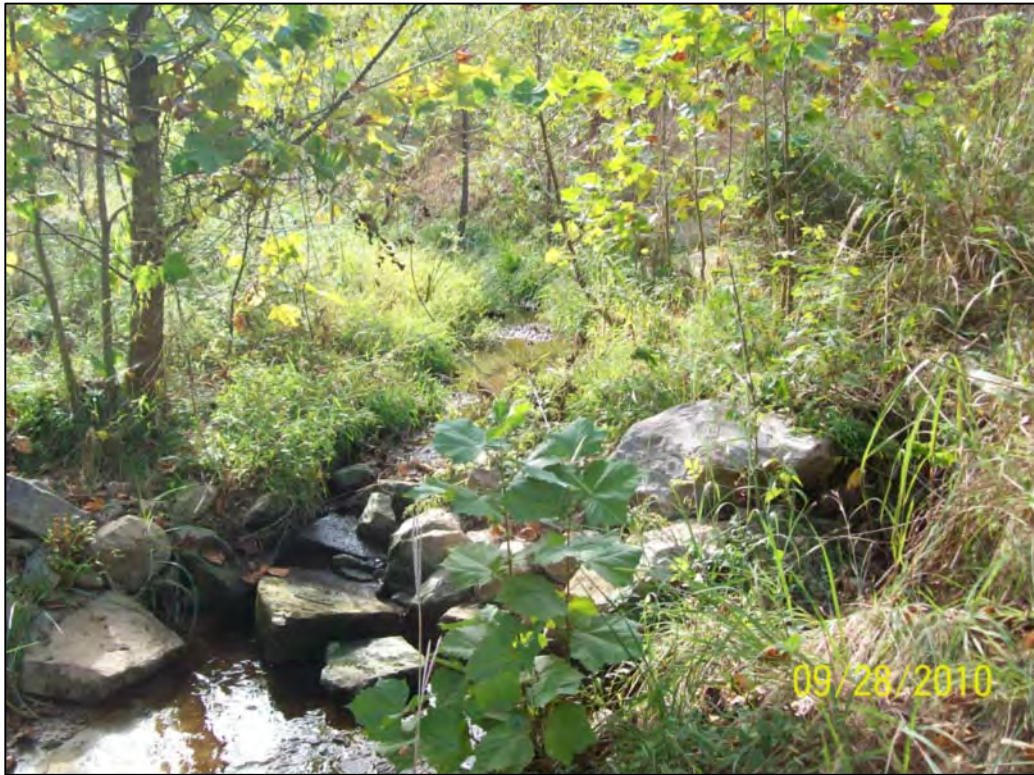
FIGURE 7.0 - PARCEL 6, LOCATION 7, LOOKING UPSTREAM (ROCK WEIR)

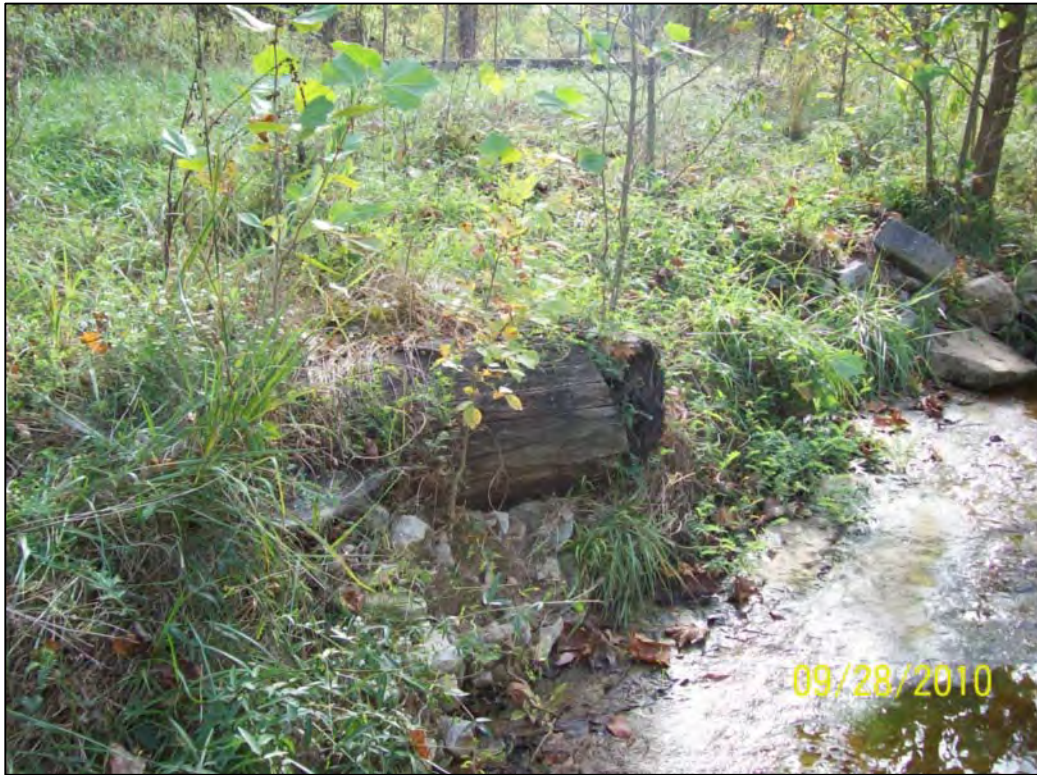
FIGURE 7.4 - PARCEL 6, LOCATION 7, LOG DEFLECTOR

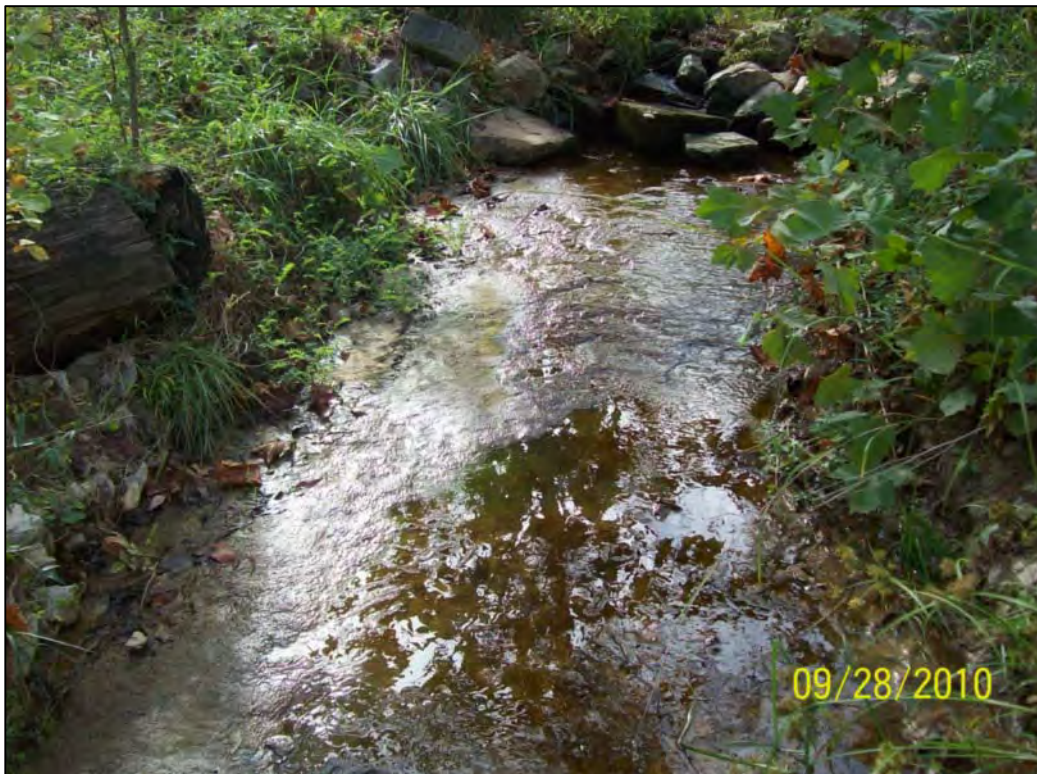
FIGURE 7.5 - PARCEL 6, LOCATION 7, SUBSTRATE IS GONE, BEDROCK, NO SIGNIFICANT BANK EROSION
