# **East Plant Area TSCA Vault Annual Report Calendar Year 2022**

**GM Bedford Castings Operations  
105 GM Drive  
Bedford, Indiana  
EPA ID# IND0060036099**

General Motors, LLC

July 10, 2023

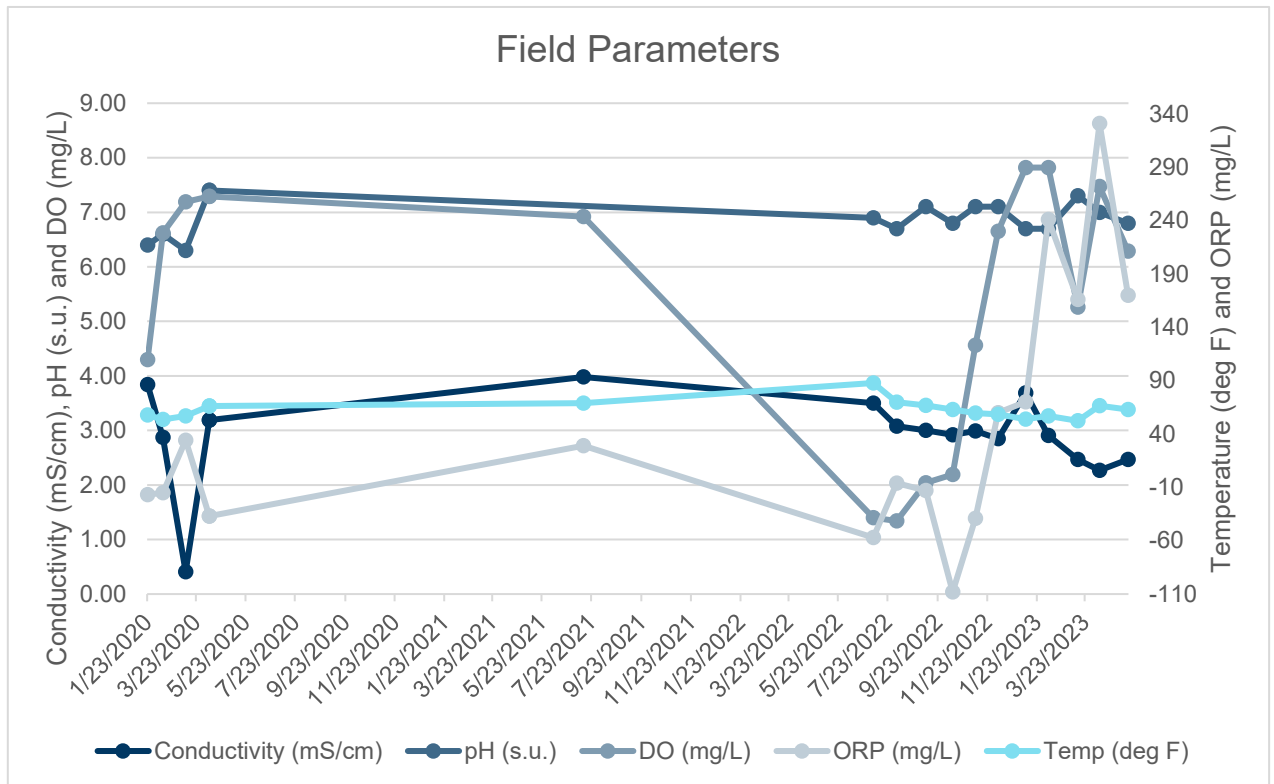
Subsequent to the October 2022 memo, GHD evaluated field parameters to see if the data provided further insights to the source of increased water as being from an internal source (normal re-distribution of liquid fraction of the disposed soil), external source (through liner failure in the cover system or bottom liner system), or transformation (biological, physical, or chemical) process.

leachate volume) were compared to recent data collected both before and after the event. The data set evaluated is provided in the table and graph below.

On July 5, 2022, the operator removed 4,452 gallons of leachate from the system and conducted the monthly sampling. The temperature from the July 2022 sample was unusually high as compared to past and future temperatures. GHD does not believe the ambient air temperature in early July contributed to the increase in temperature. GHD does not believe the temperature reading was false because of the quality control procedures implemented during sample collection.

GHD believes the temperature reading from July 5 to be accurate and evaluated the potential causes for an increased temperature and how that could have impacted the unusual increase in leachate volume during July and August 2022. GHD believes the temperature increase may be due to the generation of heat through an isolated, exothermic reaction occurring within the Vault. This exothermic reaction occurs when an anhydrous material comes in contact with water/liquid. The heat generated causes the temperature of the soil and liquid in the vicinity of the reaction to increase. If this exothermic reaction is the cause for the elevated leachate temperature seen in July 2022, unspent pockets of bed ash (mixed with soil) within the Vault may be the cause. Bed ash was used as a drying agent for material that was placed in the Vault. Hydration of the bed ash creates an exothermic chemical reaction which releases heat. The reaction could alter the mass (and subsequent volume occupied by the mass) and allow a shift of surrounding solid wastes, subsequently opening additional preferential pathways to be created for the release of stored pockets of leachate into the collection system.

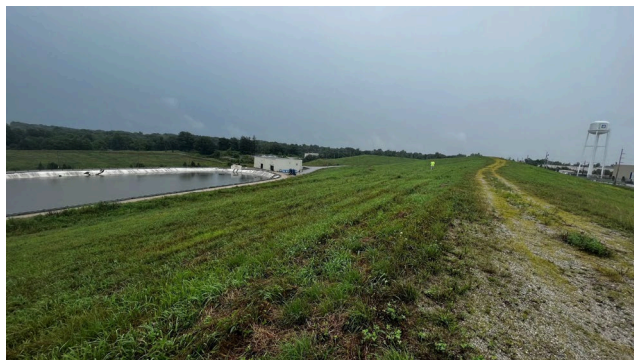
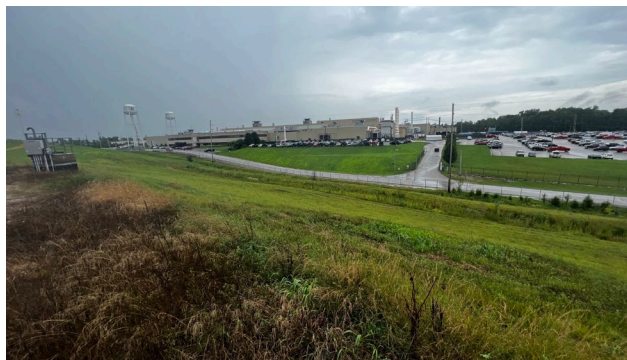
The Vault surface was inspected to identify signs of differential settling of the cover system that could point to a failure of the liner system. A recent mowing of the Vault cover system enhanced the ability to observe any signs of settling. Personnel looked for areas of slumping, surface depressions, standing water or saturated soil. Two inspections were conducted following the initial inspection by the GWTP operator. On August 4, 2022, field personnel who normally conduct the semi-annual cover system inspections walked the Vault cover system. On August 11, 2022, the Vault design engineer inspected the cover system. Neither observed signs of cover system settlement that would indicate a system failure.

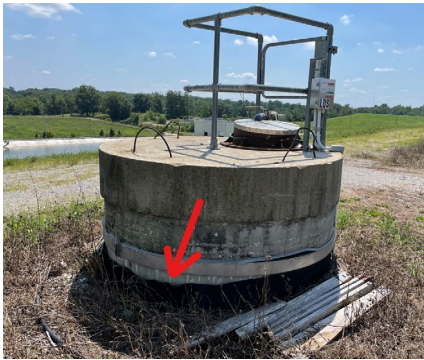
The liner around the LCS sump was inspected. This liner is part of the East Plant Area cover system. A small portion of the liner has pulled away from the restraining band where the liner is booted to the LCS sump. The liner attachment at the surface will be fixed but the small gap would not contribute to the increase in leachate volume. It is important to recall that the liner associated with the Vault cover system is similarly affixed to the LCS sump, approximately 20 feet below ground surface. For stormwater to have reached the LCS, stormwater would have infiltrated through the gap in the upper liner as well as past the restraining band where the Vault liner is booted to the LCS sump.

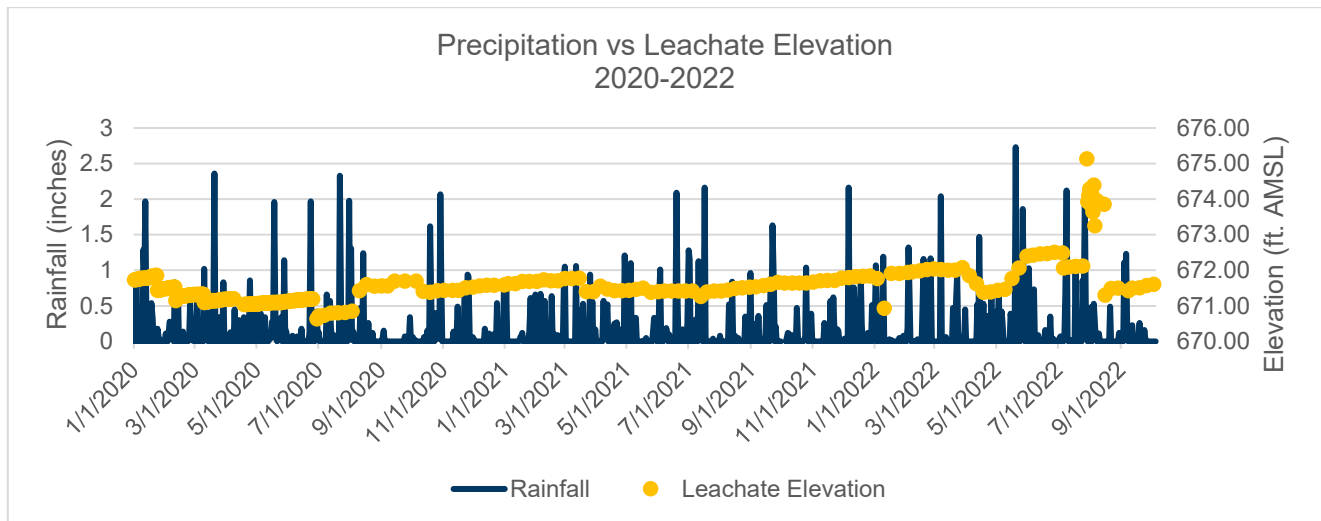
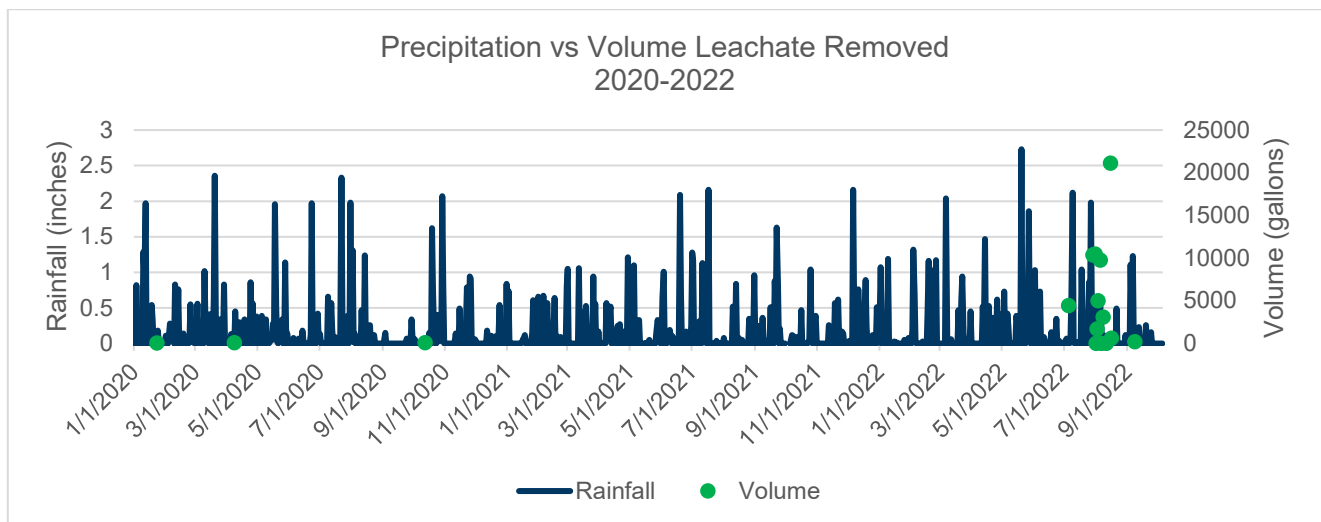
Leachate water levels and volumes were compared to precipitation to see if there was a correlation, indicating a subsurface/unseen failure of the cover system which would allow stormwater to reach the LCS. Below are charts comparing precipitation events (as recorded by National Weather Station Bedford 3.7N) to leachate water levels and volumes for the past 3 years. No correlation between precipitation and leachate water levels or volume of leachate removed was found.

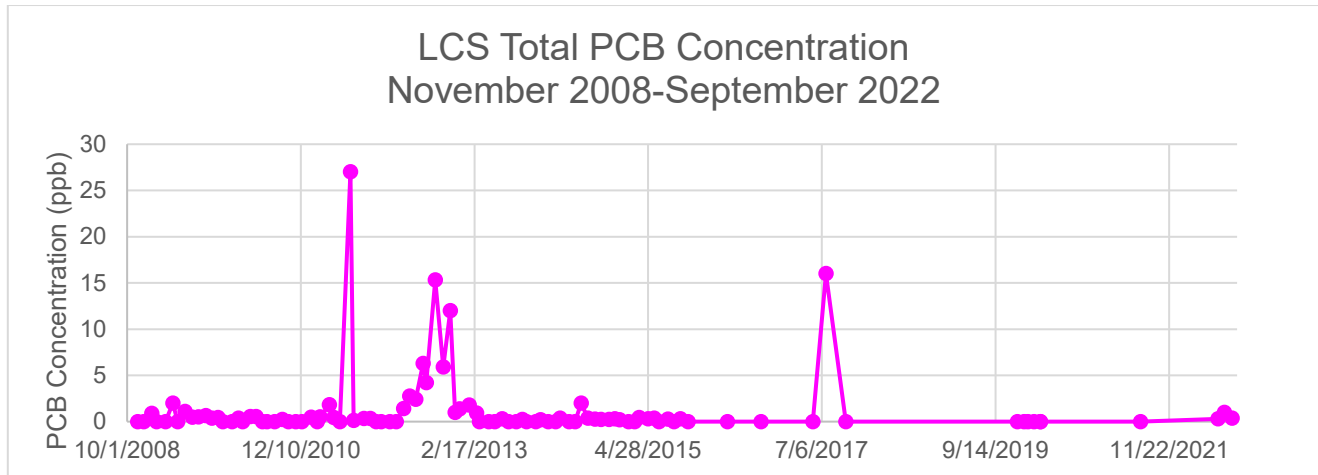
The August 2022 monthly LCS sampling event was conducted during the period where increased volumes of leachate were being removed. Total PCB data was compared to historical PCB levels in leachate following the Vault liner installation in October 2008. The result from the August 2022 sampling event (1 ppb) was consistent with the leachate sample results following the initial dewatering of the soils within the vault. The total PCB concentration from the September 2022 event showed a decrease in total PCB concentrations (0.35 ppb) from the August sampling event.

Sample results from the LDS during August and September were non-detect for PCBs. PCB concentrations in the groundwater below the LDS averages 30 ppb PCBs. This is consistent with the assessment that there is no connection between the LDS and LCS and that the water collected from the LCS was not from groundwater.

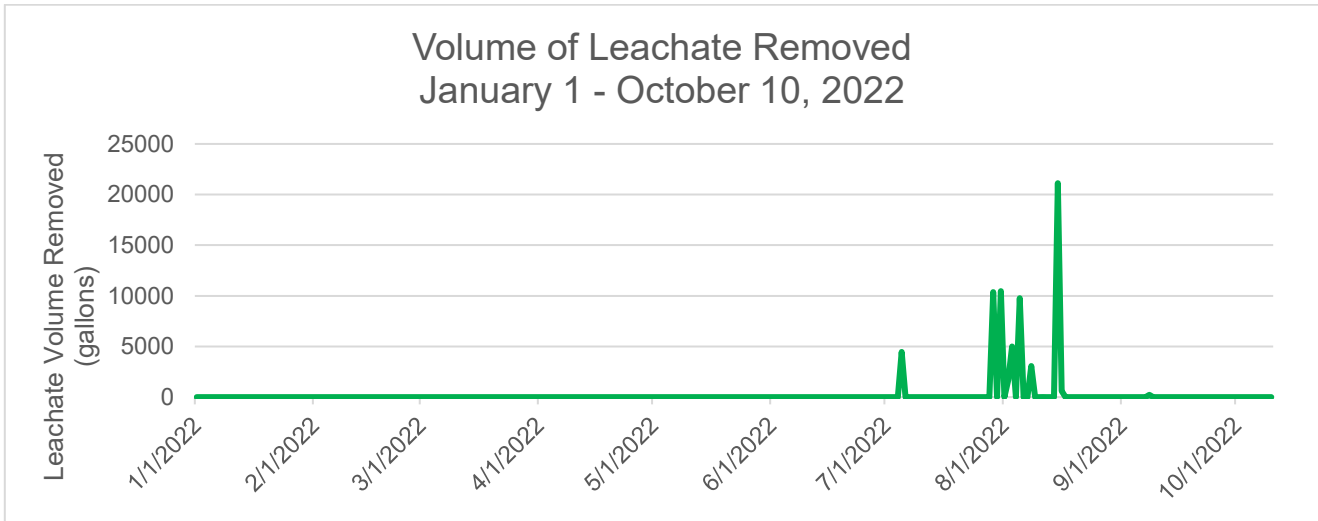
The leachate elevation within the LCS slowly builds over time. As expected, the rate of leachate production and collection has significantly diminished since Vault closure with less than 1000 gallons/year over the past several years, including several years where no leachate was collected. In the months leading up to the July 2022 leachate measurements, no leachate was collected until July 5, 2022, when the operator manually removed 4,452 gallons during a monthly sampling event. Between July 29 and August 8, 2022, a total of

40,353 gallons of leachate were removed. The August 15, 2022 spike in removed volume shown on the graph below was a result of testing the pump communications and controls, not due to a rise in leachate levels. Subsequently, no leachate has been removed excepting 213 gallons on September 8, 2022, as part of the monthly sampling event.

Note that the “volume removed” readings from January – July 2022 which were attributed to signal variations/fluctuations were not considered in this evaluation. Manual measurements of leachate levels during this time period indicated that leachate levels within the LCS had not risen to a point in which the pump would automatically be engaged. Further, it was determined that the negative transducer readings (recorded during this same time frame) indicated that the water level is below the measuring range of the device.
