# **East Plant Area TSCA Vault Annual Report Calendar Year 2022**

**GM Bedford Castings Operations  
105 GM Drive  
Bedford, Indiana  
EPA ID# IND0060036099**

General Motors, LLC

July 10, 2023

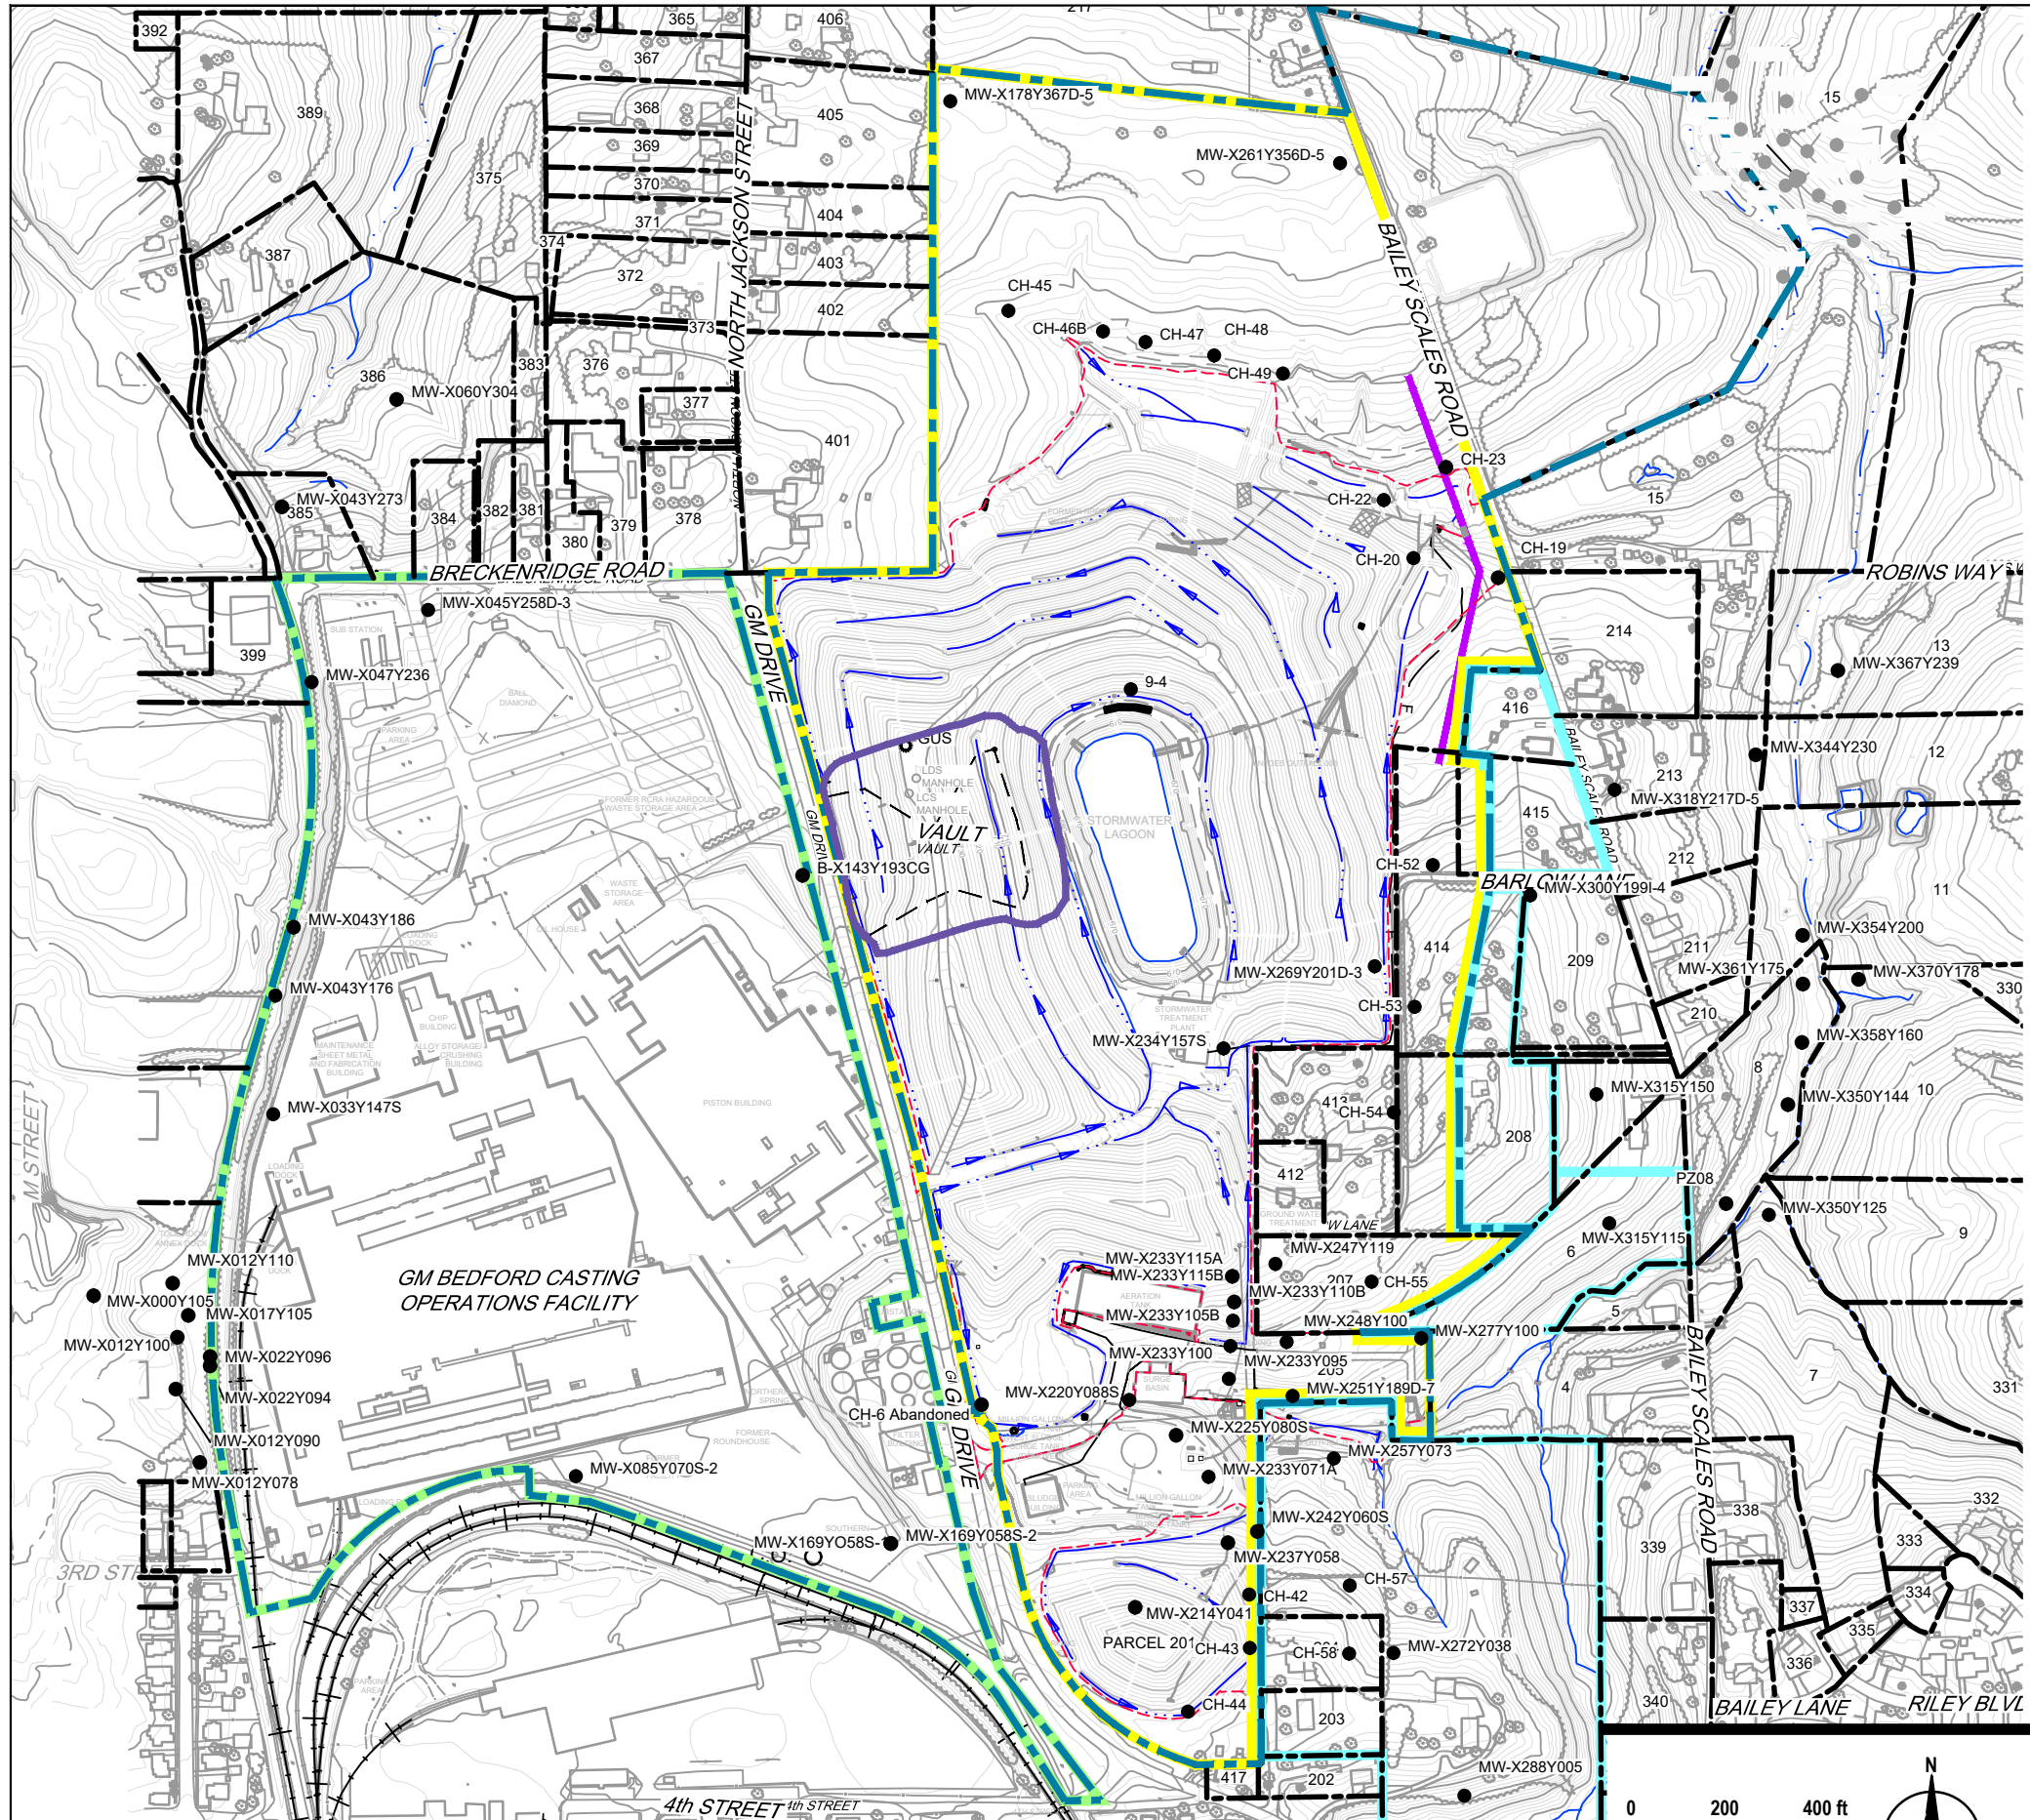
FIGURE 3.1

Groundwater sampling specific to the Vault is conducted at locations 9-4 and CH-20. The closest well in proximity of the Vault is well 9-4. The GUS sump is no longer monitored as part of this program due to inaccessibility. In accordance with the September 18, 2014, responses to U.S. EPA's March 18, 2014, comments on the PCP, sampling at these locations is coordinated with the biannual Environmental Indicator (EI) CA750 monitoring program. The theoretical leakage action rate of the LDS did not significantly change in 2022 (see Section 5.2 for further discussion), suggesting there was no release of leachate into the groundwater system or groundwater flow into the LDS. In addition, there is no evidence of a release from the Vault to the groundwater table based on changes in elevations in the LCS, LDS, and GUS sumps (Table 2.4). Groundwater monitoring (static water levels and/or sampling) locations under the EI CA750 in the vicinity of the Vault are shown on Figure 3.1.

GROUNDWATER SAMPLING LOCATIONS

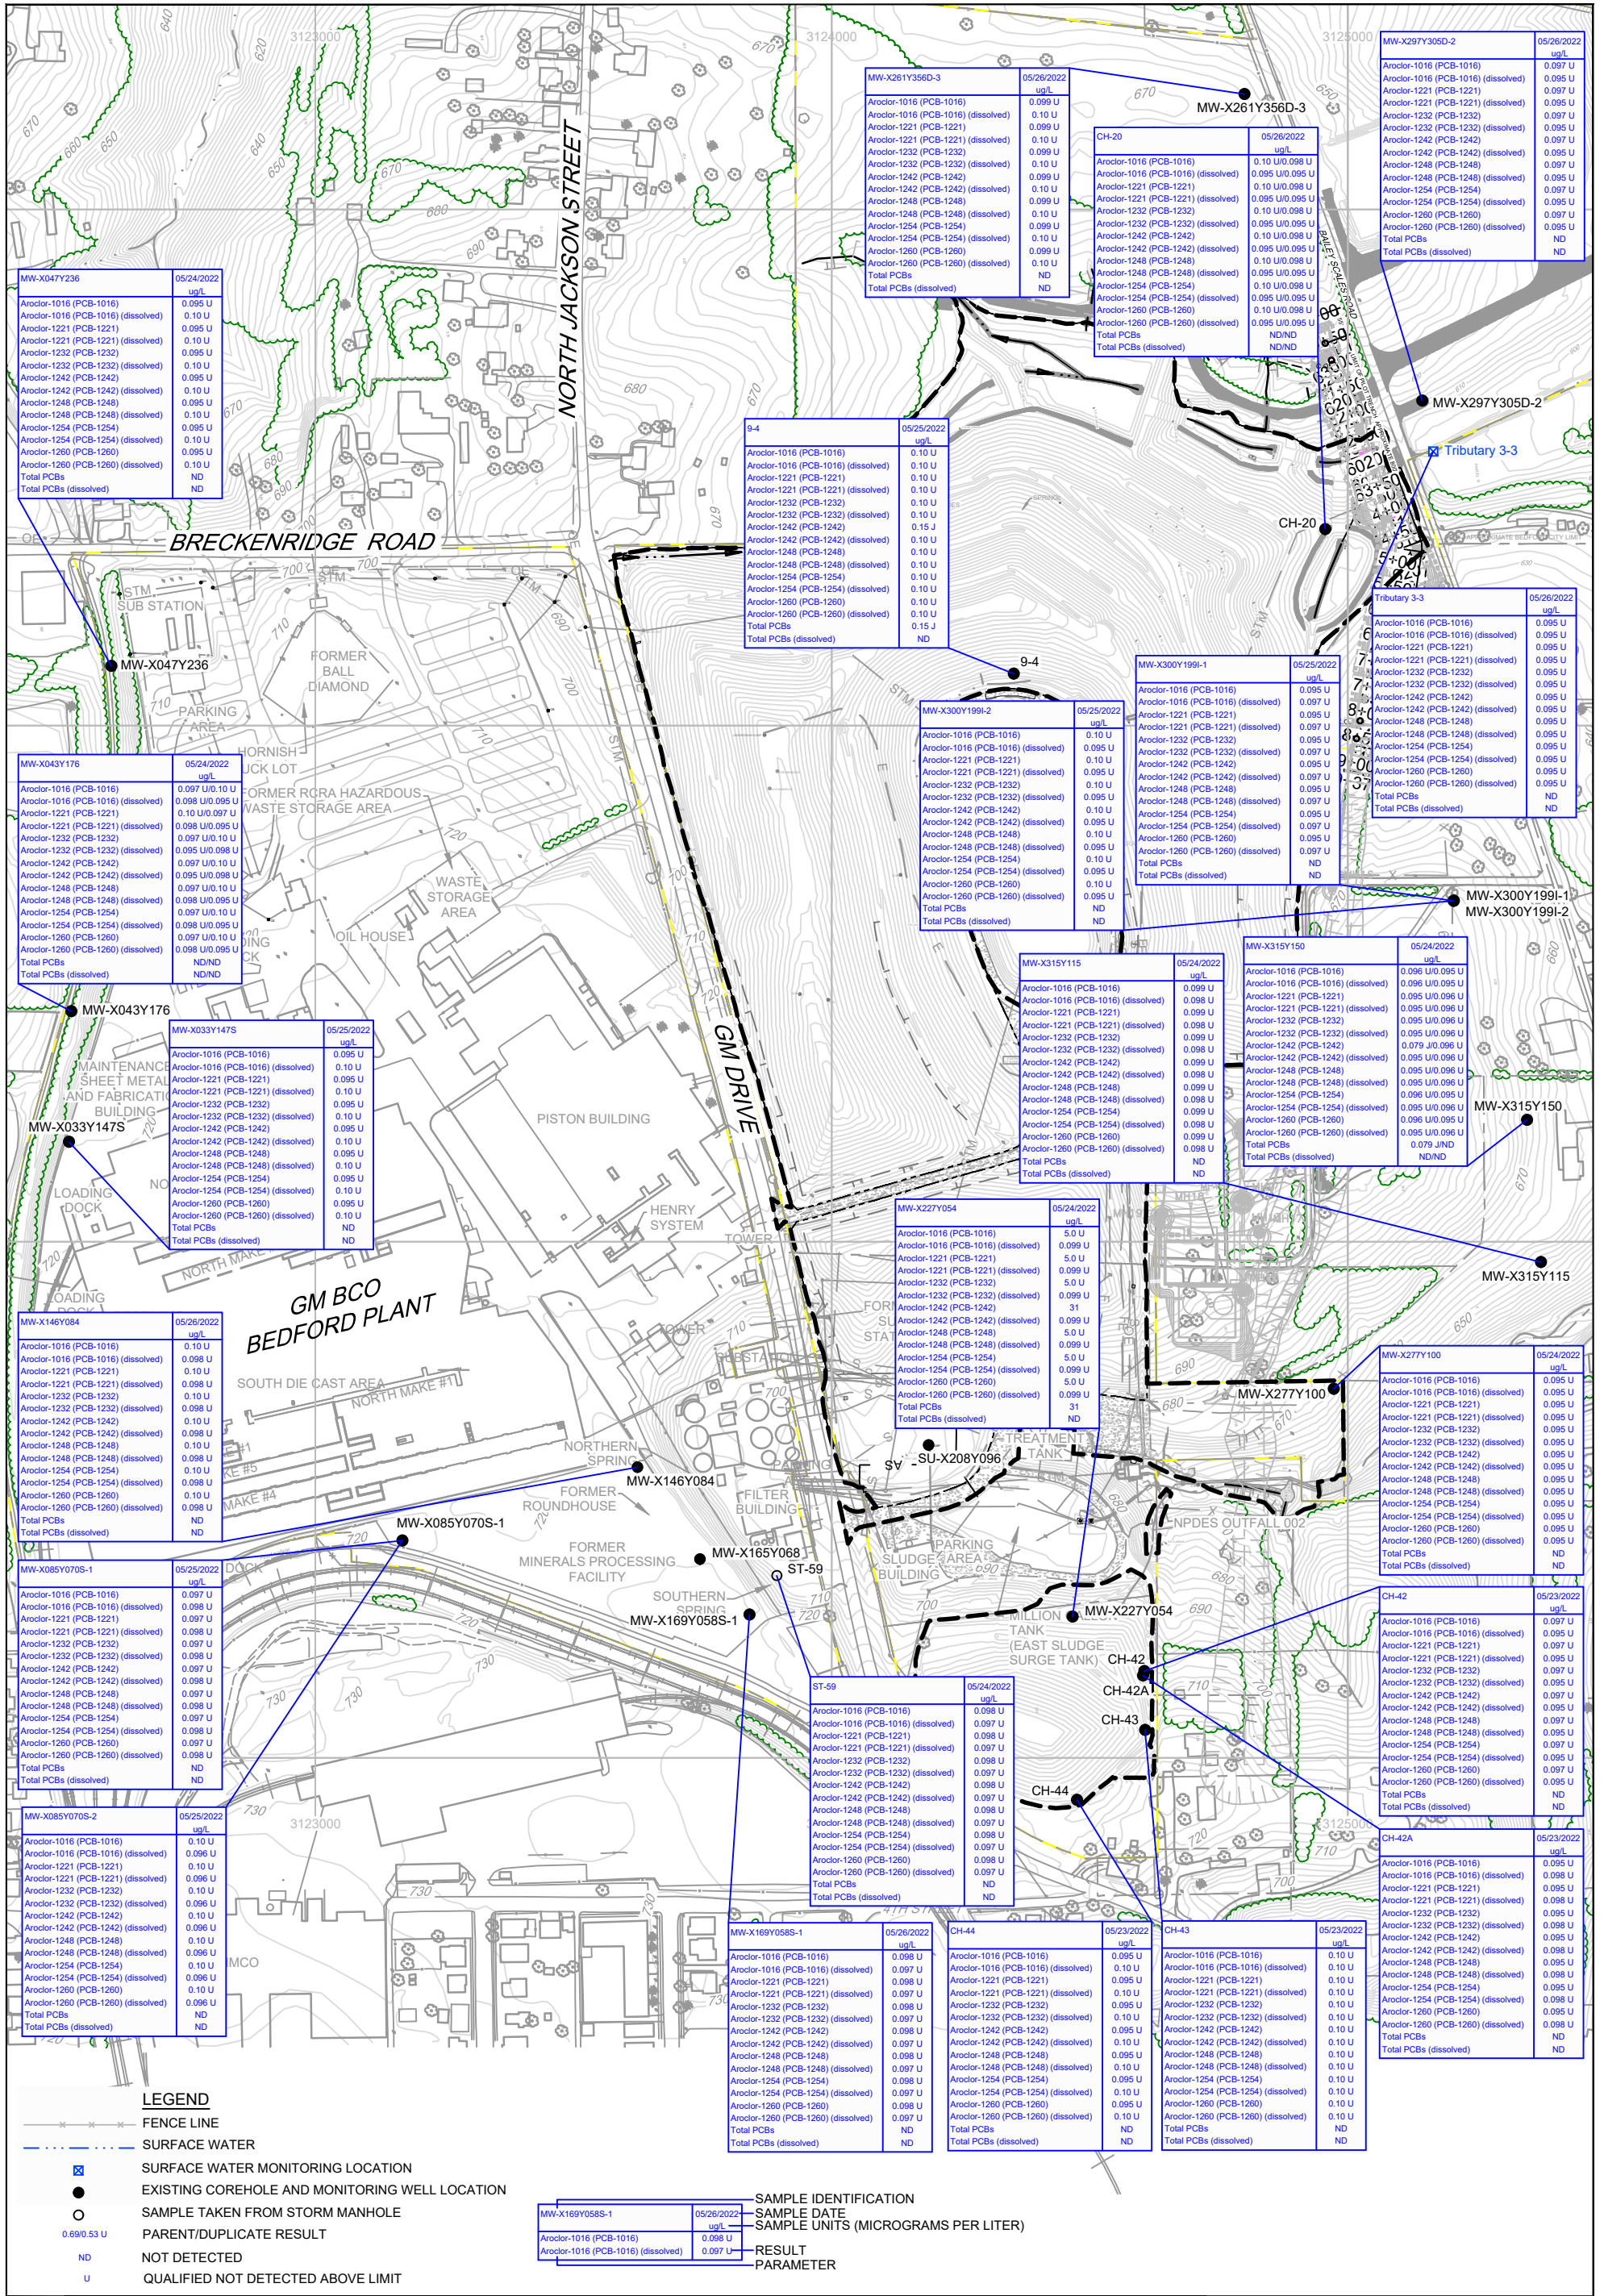
**FIGURE 3.2**

Groundwater samples are collected at the perimeter of the Facility on a semi-annual basis under the EI CA750 monitoring program. EI CA750 groundwater monitoring results for the May and November 2022 events were previously reported under separate cover and are summarized in Tables 3.1 and 3.2, respectively. Figures 3.2 and 3.3 present databoxes which summarize the groundwater and surface water analytical results for the PCBs sampling locations in the EI CA750 monitoring program for the May and November semi-annual sampling events of 2022, respectively.

**PCBs ANALYTICAL RESULT**

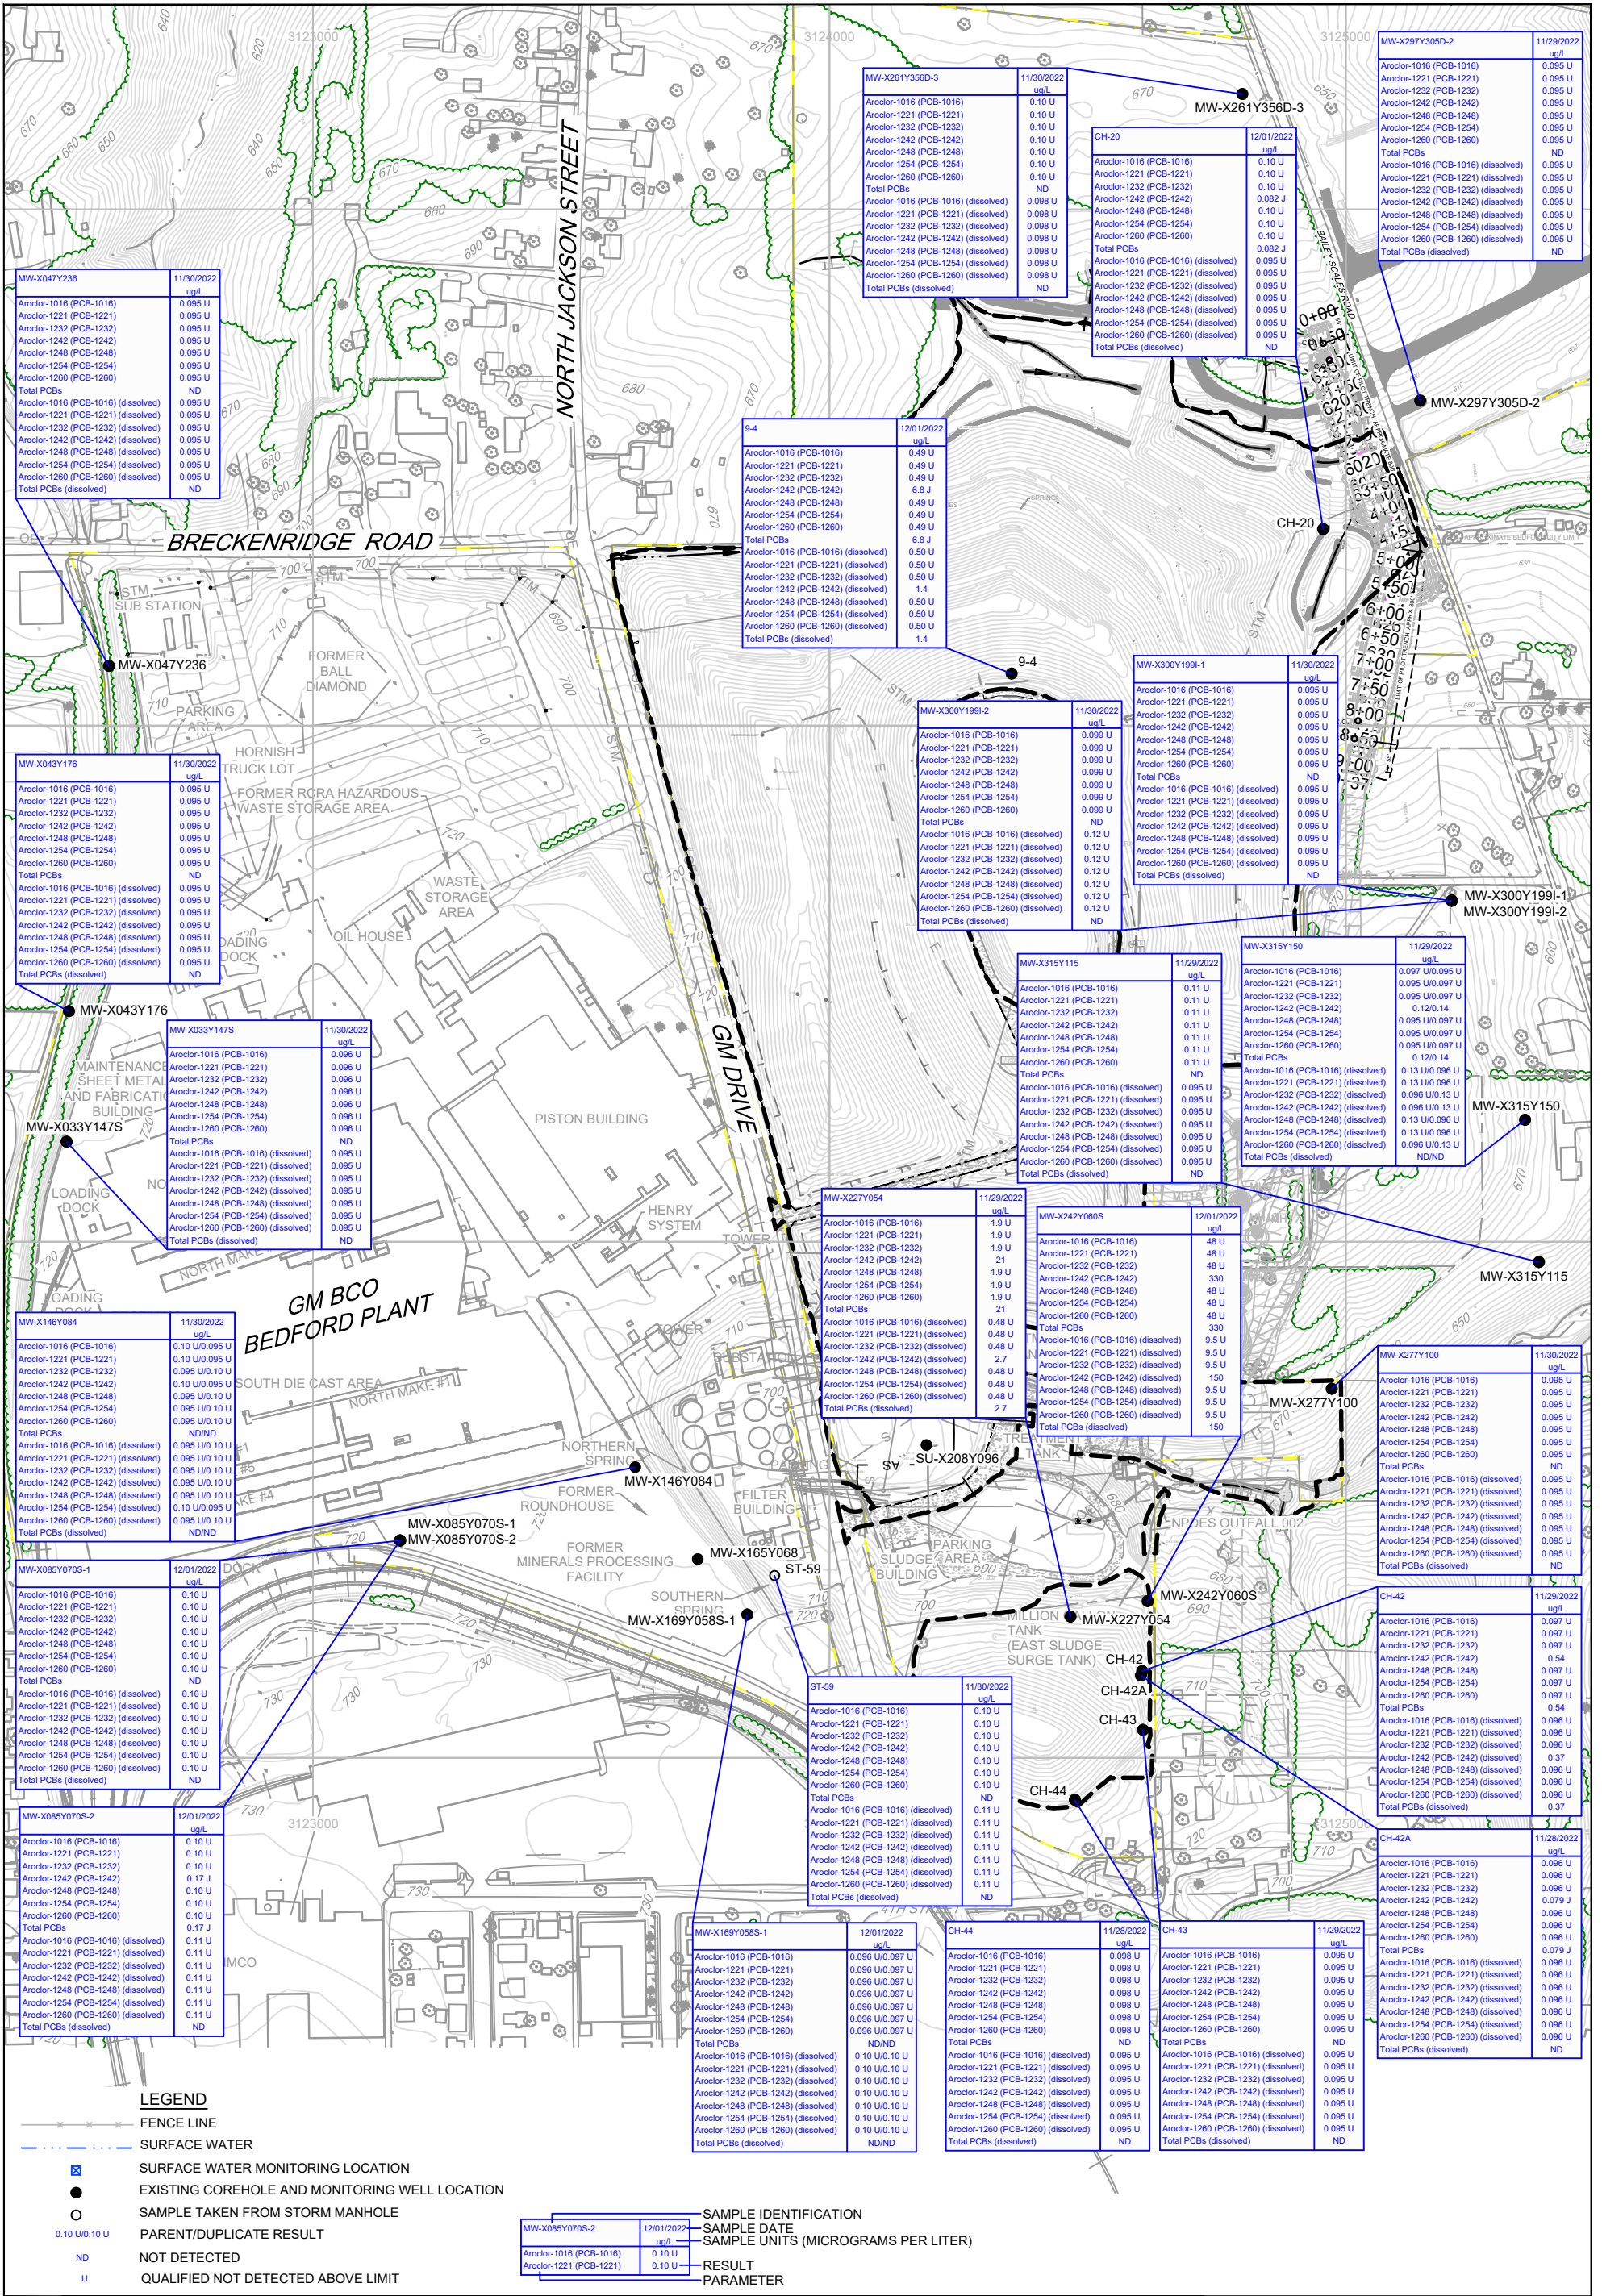
Project No. 11228036  
 Date July 2023  
**FIGURE 3.3**

**GM BCO FACILITY**  
**BEDFORD, INDIANA**  
**SECOND HALF 2022 CA750 MONITORING RESULTS**  
**PCBs ANALYTICAL RESULT**

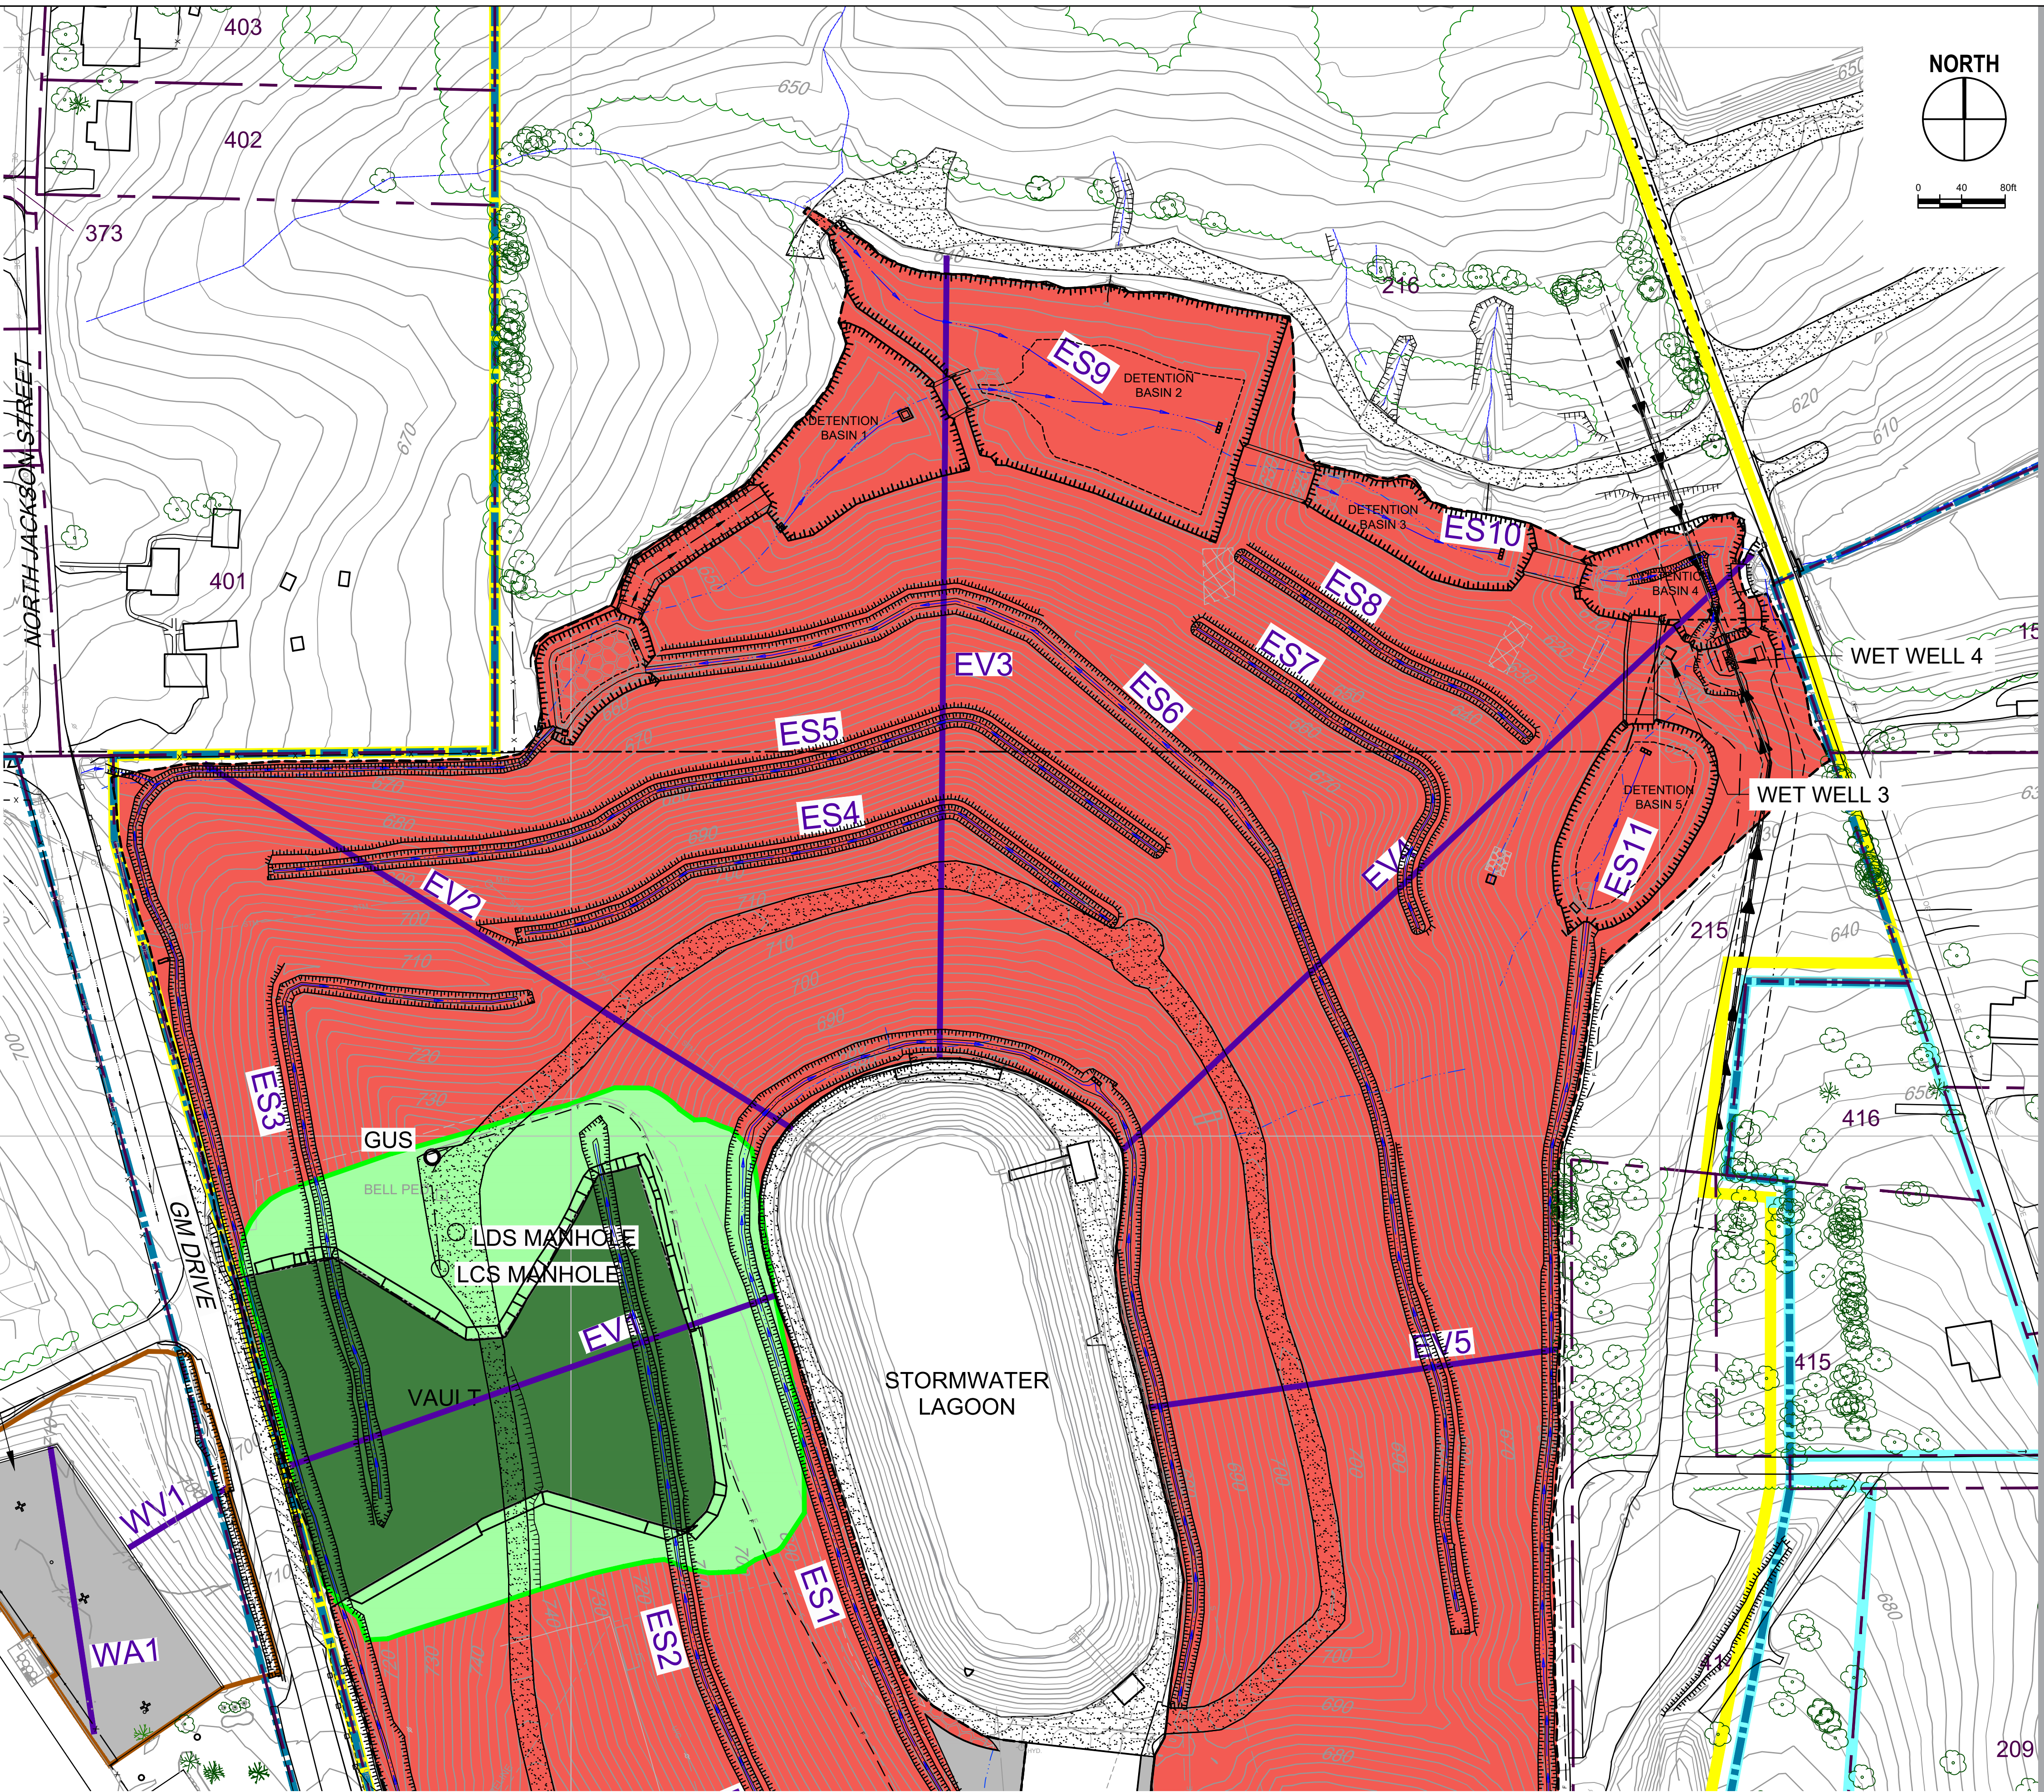
FIGURE B.1

Date	Jul 26/21	Scale	1" = 80'
Project No.	13968		
Title	<b>EAST PLANT AND WEST PLANT COVER SYSTEM INSPECTIONS</b>
