CURRENT CONDITIONS REPORT

**GM POWERTRAIN BEDFORD FACILITY
105 GM DRIVE
BEDFORD, INDIANA**

Volume I – Text, Figures, and Tables

**Prepared by:
Conestoga-Rovers
& Associates**

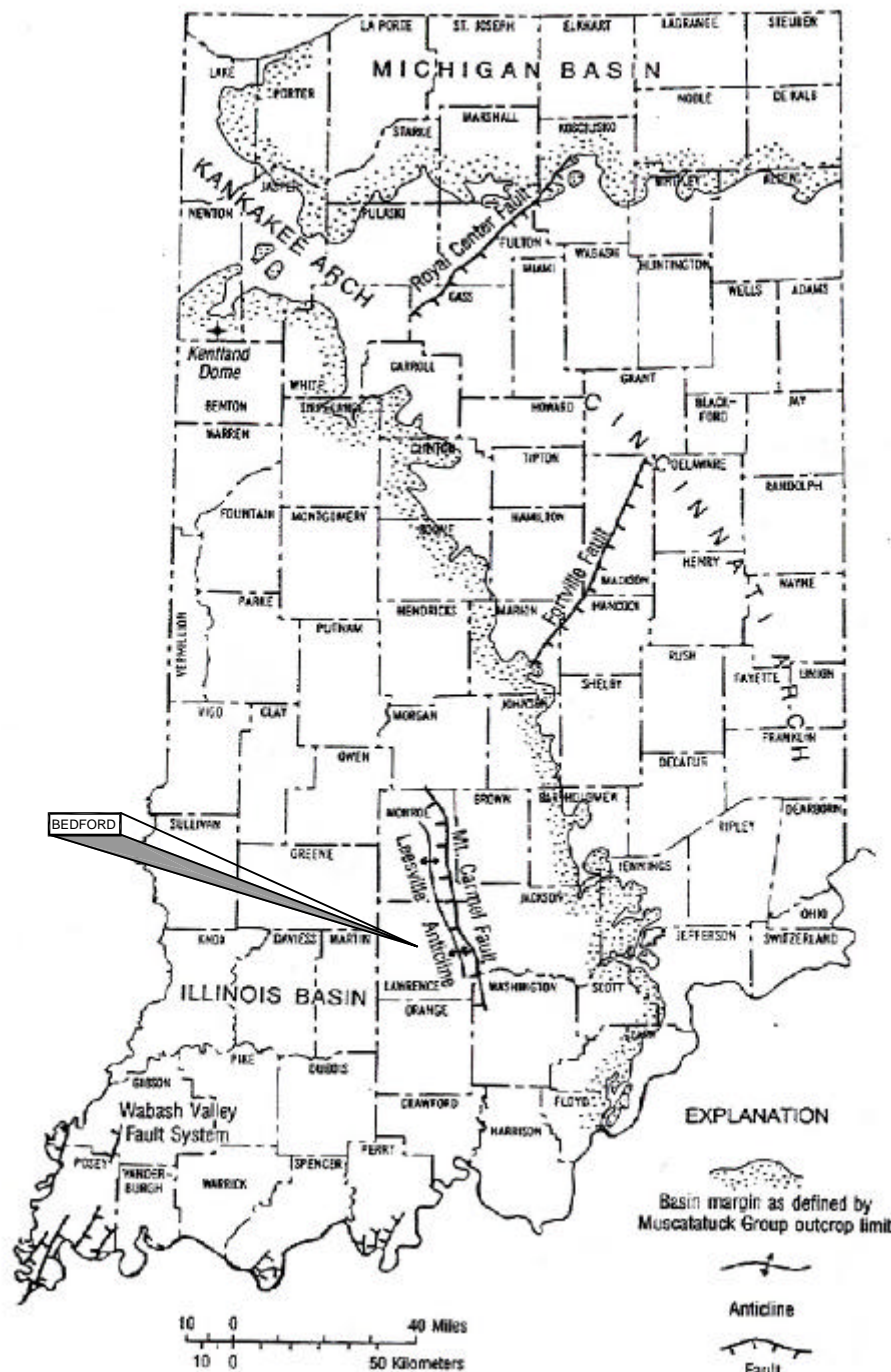
figure 3.3

BEDROCK STRUCTURAL FEATURES OF INDIANA
GM POWERTRAIN BEDFORD FACILITY
Bedford, Indiana

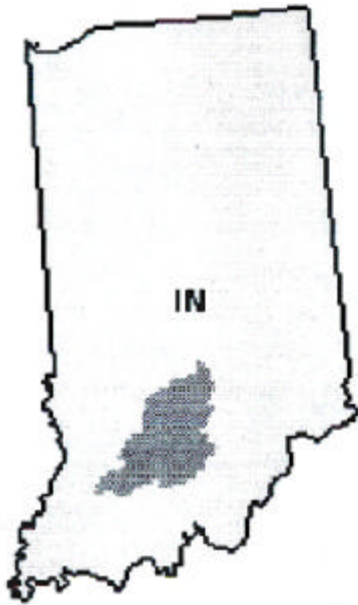
figure 3.6
LOWER EAST FORK WHITE RIVER
DRAINAGE BASIN
GM POWERTRAIN BEDFORD FACILITY
Bedford, Indiana

Rivers in the eastern half of the East Fork White River Basin have a subparallel drainage. Those rivers include the Sugar Creek, Big Blue River, Little Blur River, Flatrock River, Clifty Creek, Sand Creek, Vernon Forth, Graham Creek, and the East Fork White River from Medora to Jonesville (see [Figure 3.6](#) for the Lower East Fork White River Drainage Map).
